Subject: "FIRE" Back of Crew Cab vehicle

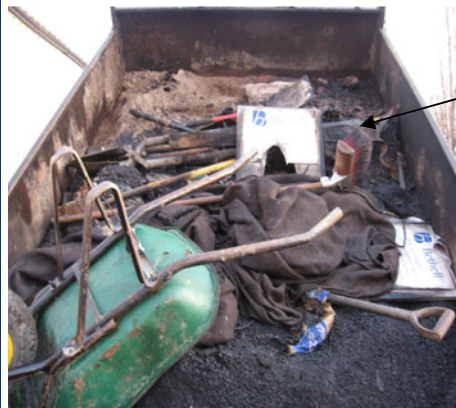
Body of Crew Cab Vehicle was engulfed in flames causing substantial damage. Fortunately no one was hurt but the consequences could have been of a serious nature.

Using naked flame and petrol to burn off residue tarmac on tools on the back of the vehicle. The fire was initially extinguished by five fire extinguishers but due to additional fuel on the rear of the vehicle (diesel) which was stored in a 5 gallon plastic container, an additional fire started caused the damage.

The incorrect vehicle was used and diesel was spread across the body to prevent the coating of the raw material sticking to the body of the vehicle.

Body of Vehicle

- That on no account must diesel or petrol be used for the cleaning of tools.
- The correct method is to pre heat tools in a specialist pre heat box or alternatively to use an industrial cleaning spray.
- Crew Cabs MUST not be used to carry hot lay materials, the body of the vehicle must be insulated.
- Operatives MUST hold the correct accreditation for hot lay materials.
- All fuels must be stored in the approved metal containers and not in plastic containers

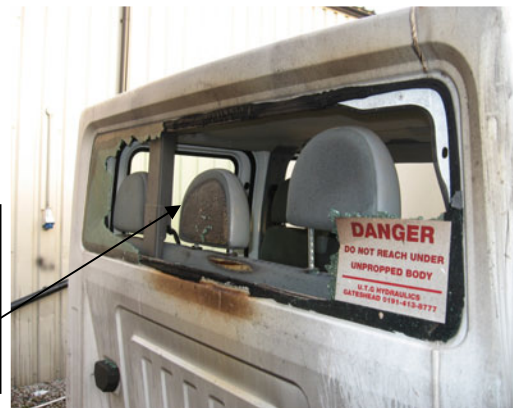
Smashed window due to the heat of the fire
