Dan Bank Road and Slope Stabilisation

The overall project is designed to stabilise the movement of the A626 Stockport to Marple Road, which had suffered from settlement and lateral movement, as the road foundations were slowly sliding down the embankment towards the watercourse known as Marple Brook.

Stockport Metropolitan County Council

A626 Stockport Road, Marple, Cheshire

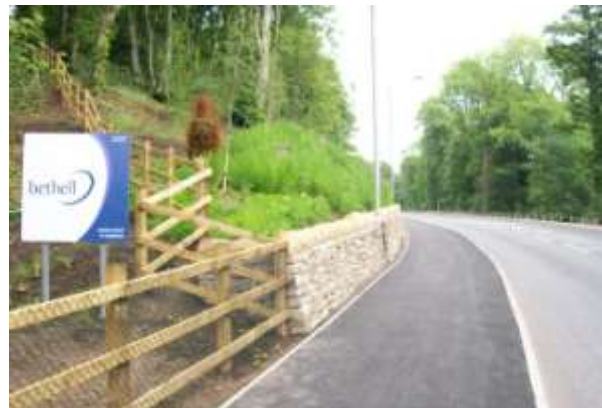
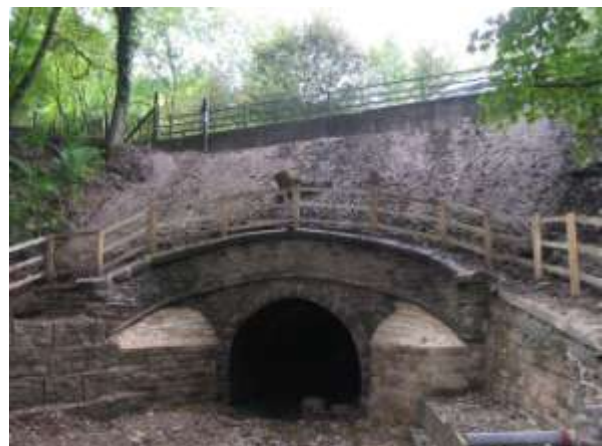
Phase 1

Bridge Improvement & Scour Protection Works

Refurbishment improvements were required to the bridge masonry arch located at the bottom of “Dan Bank” that carries the A626 over Torkington Brook. The work consisted of the repair and re-pointing of the bridge structure, plus the reinforcement and extension of the old masonry wing walls. Ant-scour protection measures were incorporated up stream of the bridge structure and included the installation of structural gabions and the underpinning of the existing bridge foundations.

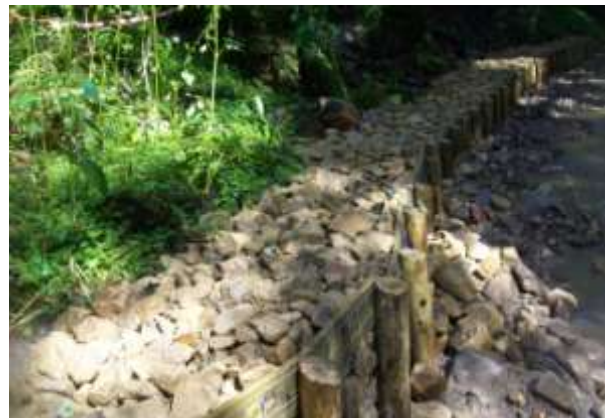
Phase 2

Slope Stabilisation Drainage and Marple Brook Improvement Works

These works were designed to improve the natural subsoil drainage of the slope and promote less silting and better water flow in Marple Brook at its base. New land drainage wrapped in geotextile and covered in lime free gravel was installed from the Brook, up to the slope to the main road. Separate drains, catch pits and silt traps were also installed to catch the surface water runoff from the road gullies. Marple Brook was cleaned of debris and scour protection measures were installed, using environmentally sympathetic timber and pre planted coir materials. The majority of this work was completed manually by Bethells skilled labour force, this being the best way to reduce the environmental impact that any construction activity had on the site.

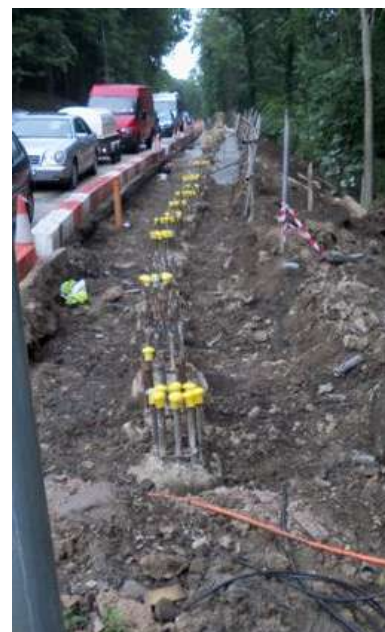
Phase 3

Road and Ground Stabilisation Works

The scheme required the installation of nearly 300 600mm dia x 8/12 metre long contiguous reinforced concrete piles to form a 300m long r structure to reatin the A626 and the slop above. The contiguous piles were linked at road level by a reinforced concrete pile cap. New road drainage, storm water interceptors and steel rope vehicle restraint system were installed and fitted.

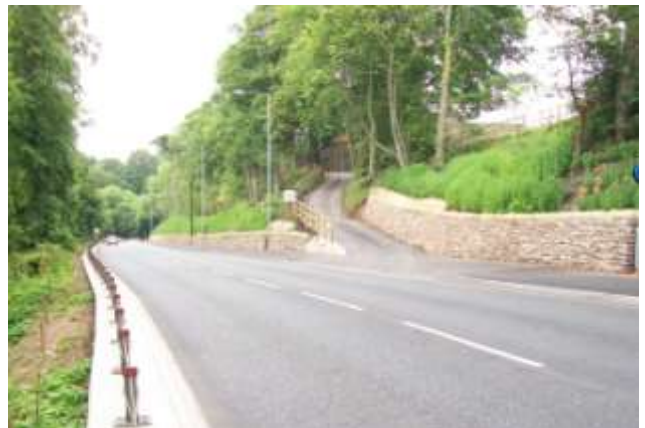
Phase 4

Road Surfacing and Reconstruction & Dooley Lane Junction improvements

The final phase required further slope stabilisation work, this time to the uphill slope above the A626. This part of the scheme involved the installation of geo-textile materials and 350 soil nails up to 15 metres in length. This allowed the excavation of the existing embankment to enable the extra width necessary to construct a new stone retaining wall

Concurrent with the wall construction, the existing asphalt road and kerb line was replaced in its entirety. Once again all the works were carried out at night throughout the evenings between the hours of 7pm and 6am to eliminate any traffic chaos.
